# Buffalo Lake

# Water Quality Sampling Results

Ted Johnson  
DNR - Lake Biologist

September 6<sup>th</sup>, 2025

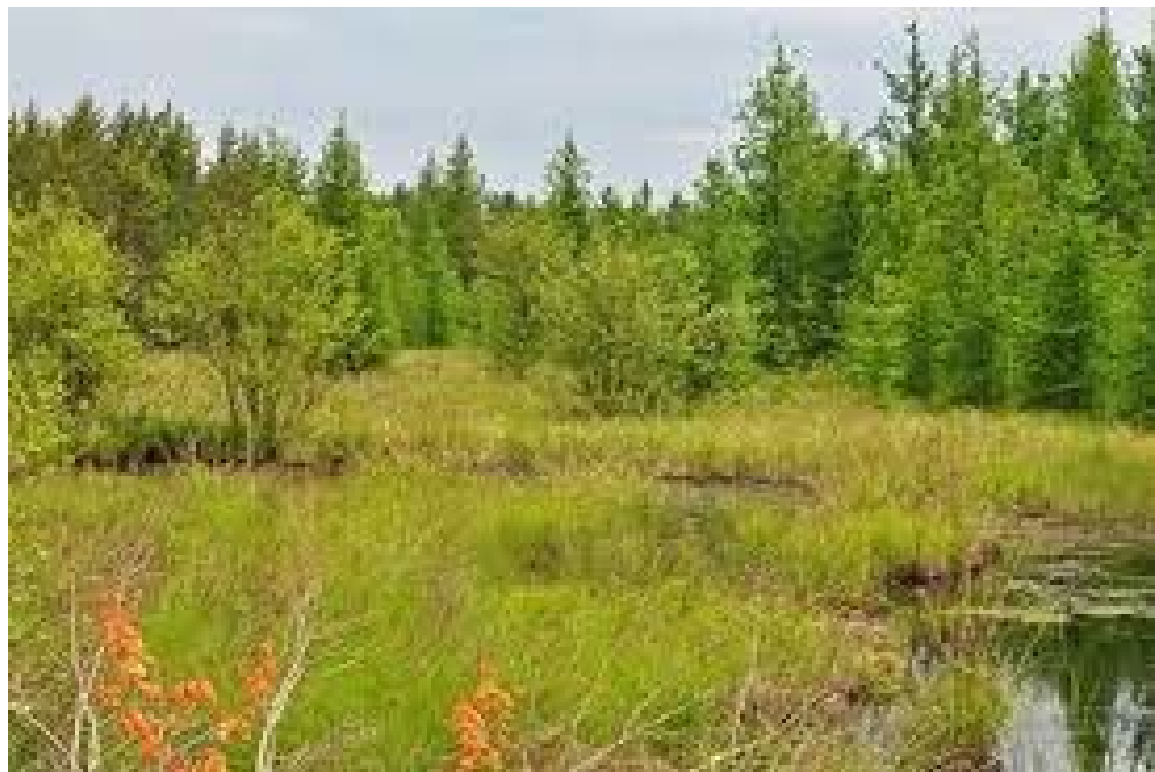
# Buffalo Lake Watershed

- Large storm events → rapid runoff → delivery of tannic acids → reduced clarity

- 257,418 Acres
- 19% Wetland (36,000 acres)

Tanin Stained

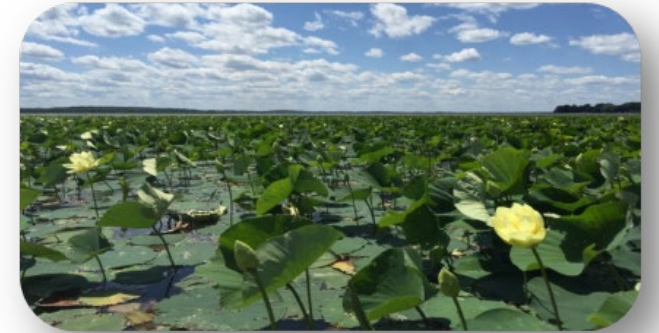
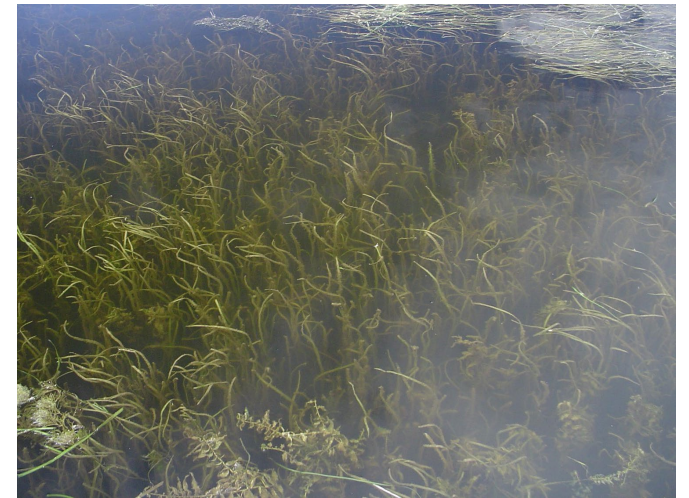
# Benefits of Aquatic Plants

- Increased water clarity
- Better water quality
- Reduced algae
- Root systems stabilize lake-bed sediment, hold it in place.
- Use and storage of nutrients such as phosphorus
- Increases zooplankton habitat (refuge).
- Critical habitat for fish & wildlife.
- Reduces wind/wave energy.
- Protects shorelines from erosion.

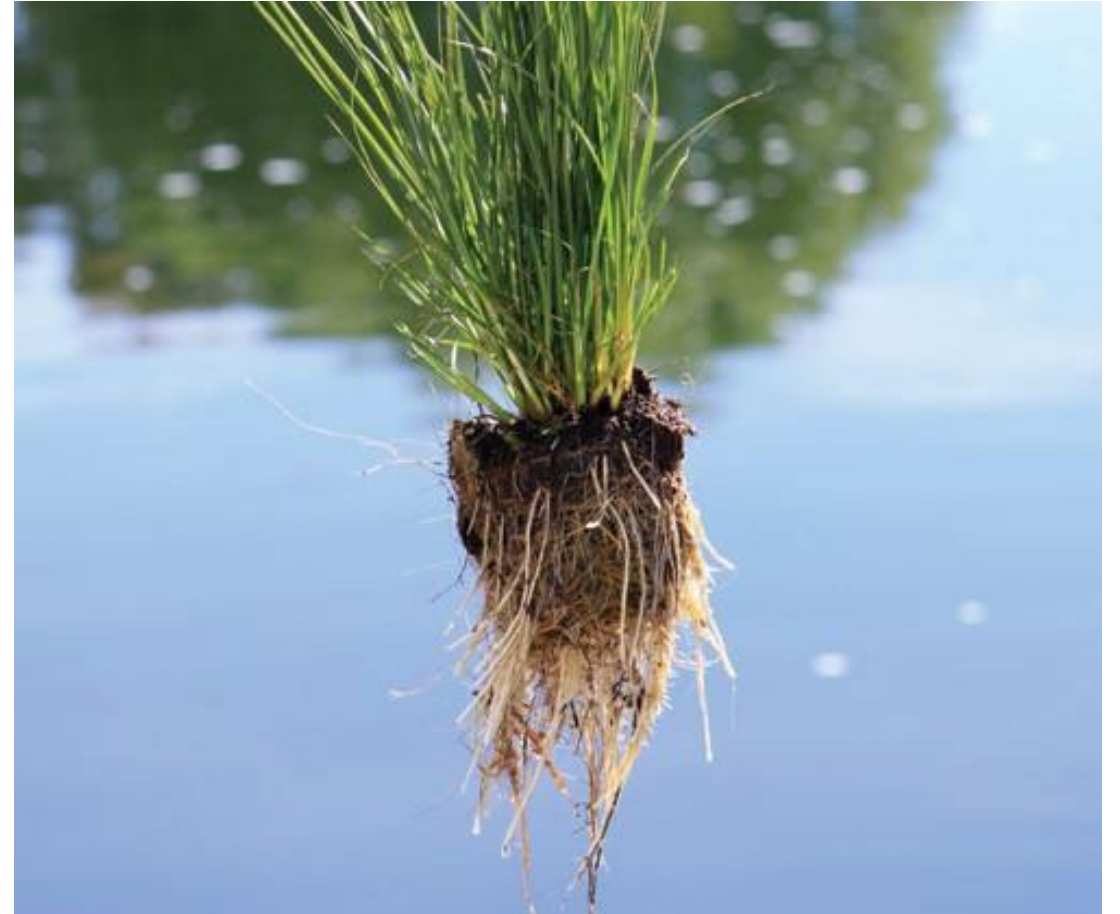
# Role of Aquatic Plant Root System

- Water and nutrient uptake from sediment.
- Energy storage / reserve.
  - Photosynthesis converted to sugars
  - Energy reserves needed when plant is under stress or low-light conditions.
- Cutting plants causes stress and staining of water limits light penetration.
  - Finite amount of stored energy.

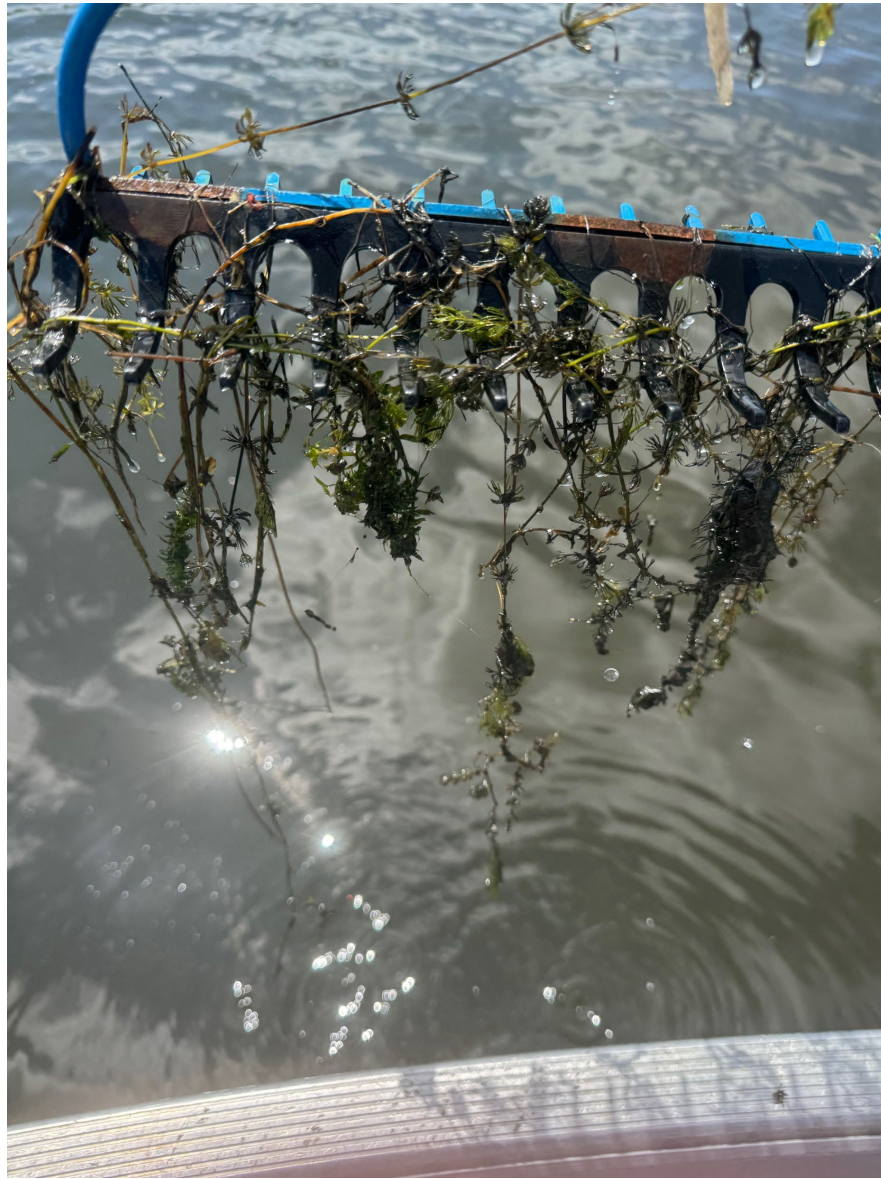
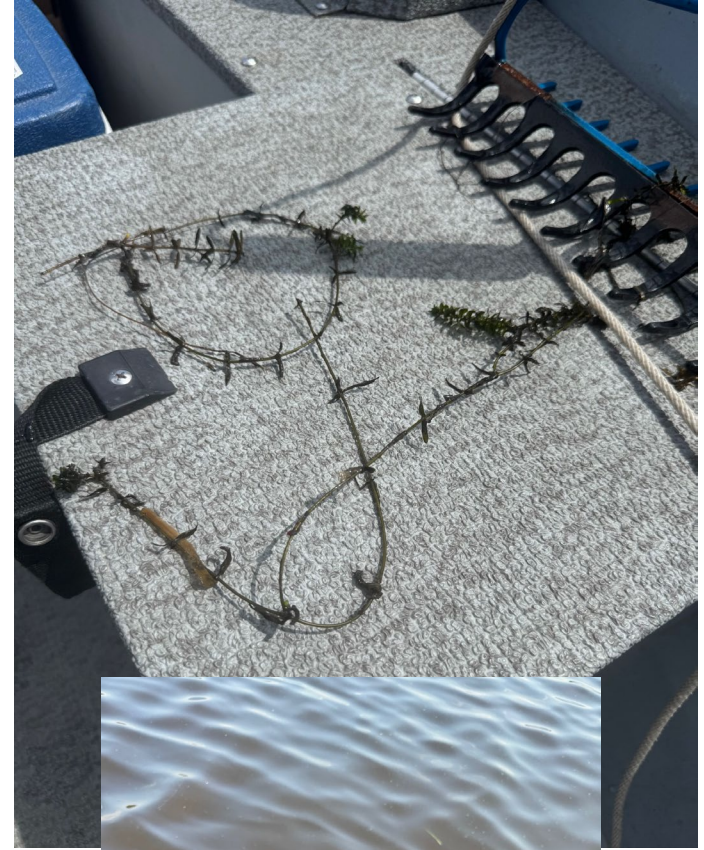
# Aquatic Plants Dying in Harvest Lane 6/17/25

- Plants were 2-3 feet tall with only the tips still green.
- By June 26, most plants were dead and hard to capture on rake.

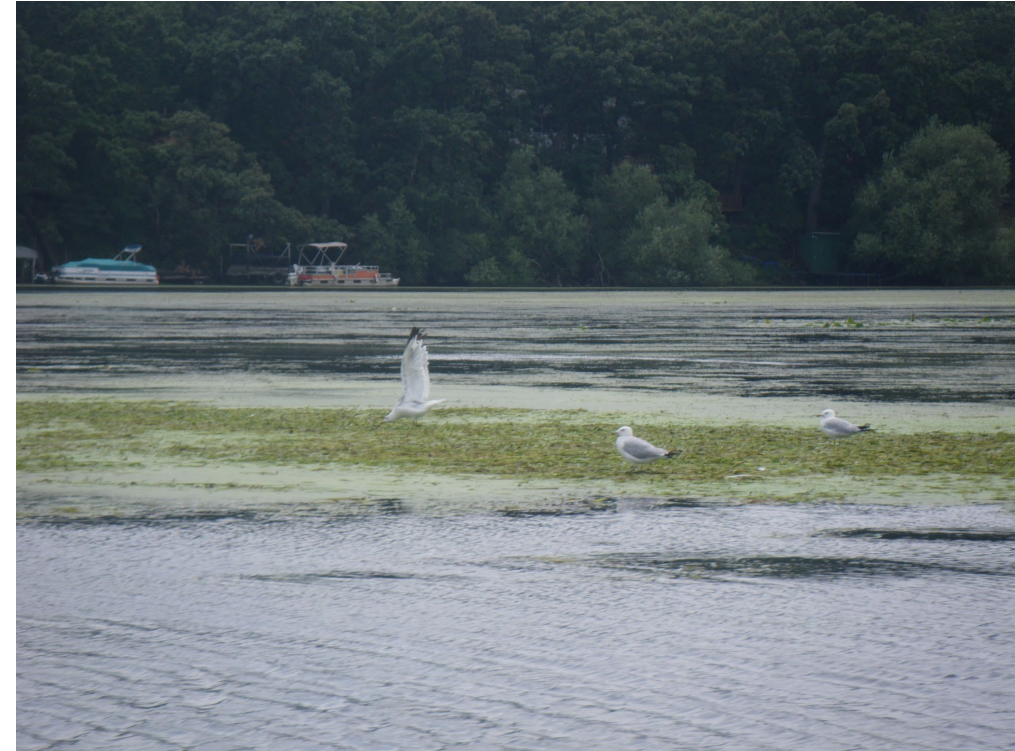
# Water Quality Impacts from Loss of Submersed Aquatic Plants

- Reduces the amount of phosphorus that would have been tied up in plant biomass.
- Increases algae both planktonic and mass forming (filamentous algae).
  - Further reduces light penetration, leads to more plant loss (Compounding).
- Decomposition of dead plants adds to internal nutrient load.
  - Lowers dissolved oxygen levels
