# Buffalo Lake

## Buffalo Lake Enhancement Project Summary Report

## Buffalo Lake Enhancement Project Hydrologic Study

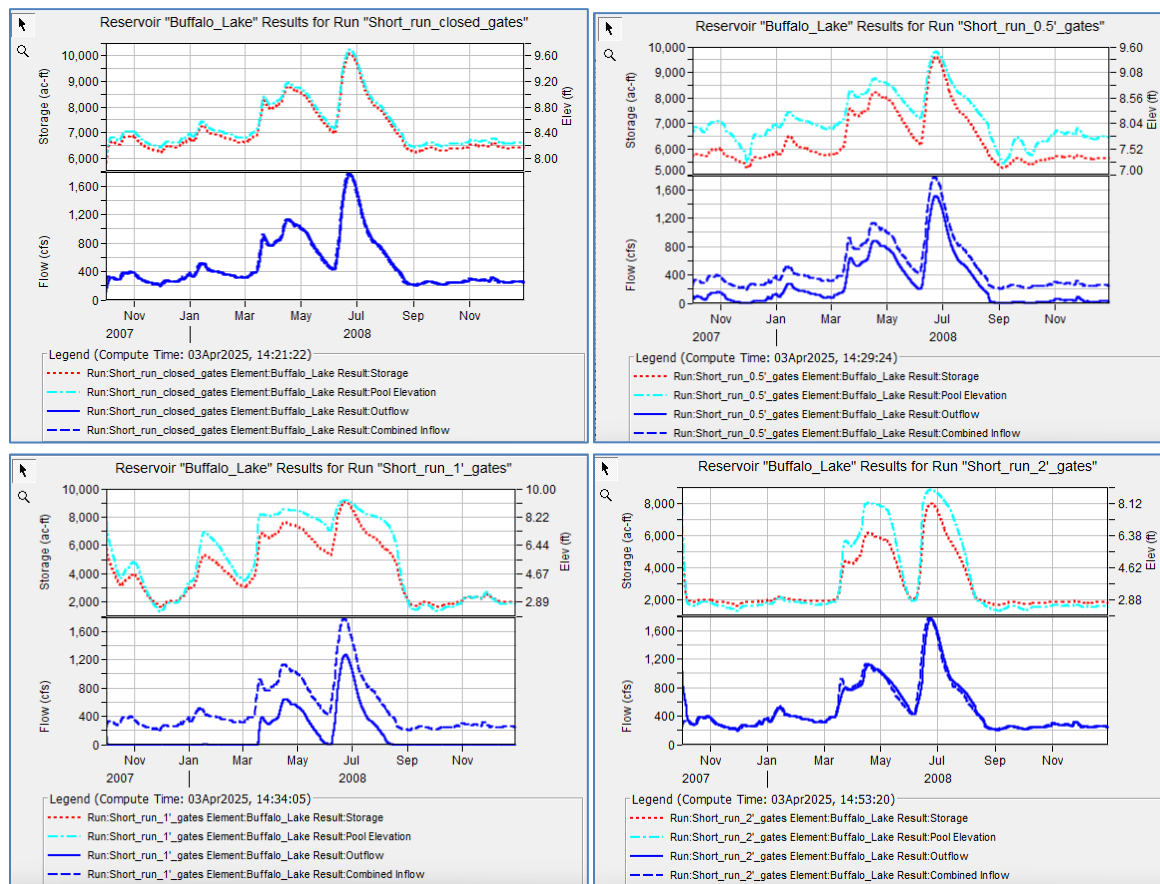
**Figure 5. HEC-HMS simulation of 2007-2008 flows for gates closed (upper left), gates open 0.5 ft (upper right), gates open 1.0 ft (lower left) and gates open 2.0 ft (lower right). Lake stage shown in light blue.**

A continuous simulation of historical flows was performed to evaluate the impact that gate settings have on the flood level of the lake. As noted above, we simulated a little over 1 year using 2007 and 2008 data for modeling efficiency. The model does not attempt to simulate actual weekly adjustments of the gates. Rather, a range of constant gate openings was modeled and compared to ascertain the difference that makes for lake flood stage. **Figure 5** shows model runs for the 4 gates being closed, and for openings of 0.5 ft, 1 ft, and 2 ft (all gates open the same amount). The runs most closely representing actual historical operation of the dam are the scenarios with the gates closed and gates open 0.5 ft. The lake stage during low flows for these scenarios is generally between 8.0 ft - 8.5 ft for the gates closed and between 7.5 ft - 8.0 ft for the 0.5-ft-opening scenario.

Also note that these simulations illustrate that gate operation can make a substantial difference in the lake flood elevation. For the largest event simulated in 2008, the peak lake stage is approximately 0.7 ft lower for the scenario with the gates open 2 ft vs. the gates-closed scenario. These means there is an opportunity to mitigate flood impacts through gate operation during high flow events.

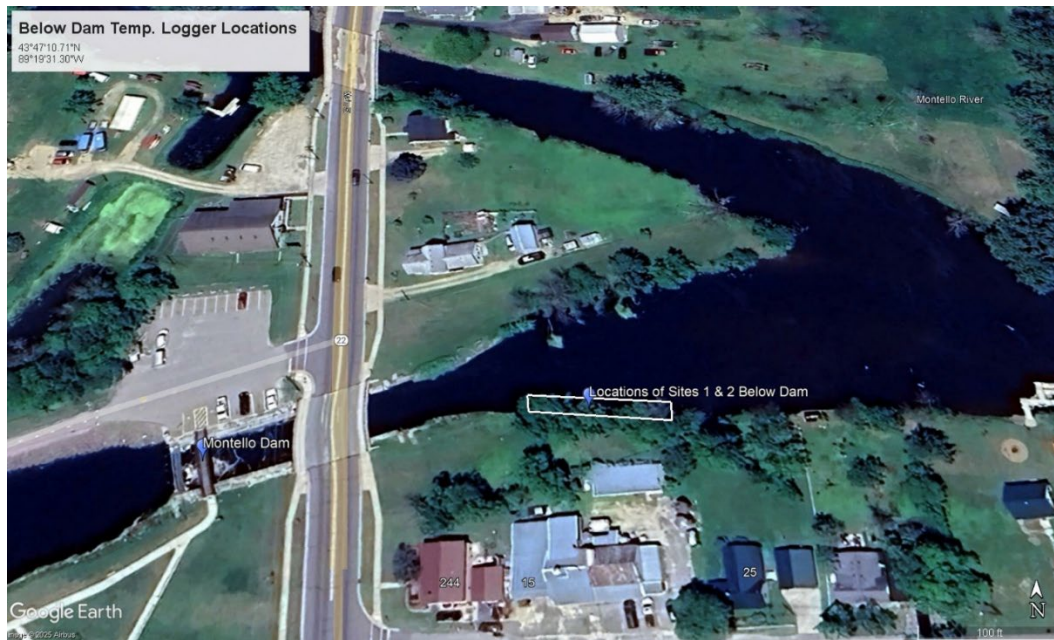
**Figure 16. Temperature monitoring location downstream of the dam in 2024.**

Cason Land & Water Management collected water temperature data at two locations in 2024. The 2024 monitoring began on May 30, 2024 below the dam gates (**Figure 16**) and upstream of the lake at CTH O bridge (**Figure 17**). The logger below the dam gates was removed on September 6, 2024 because no flow was passing through the gates. The logger upstream of the lake was removed on October 15, 2024. Monitoring for 2025 began with deployment of data loggers on April 4; results are not available at the time of this writing. Cason provided EOR with draft temperature data for a preliminary review in this report; Cason will provide the full dataset and final analysis after the monitoring has been completed in a subsequent document.

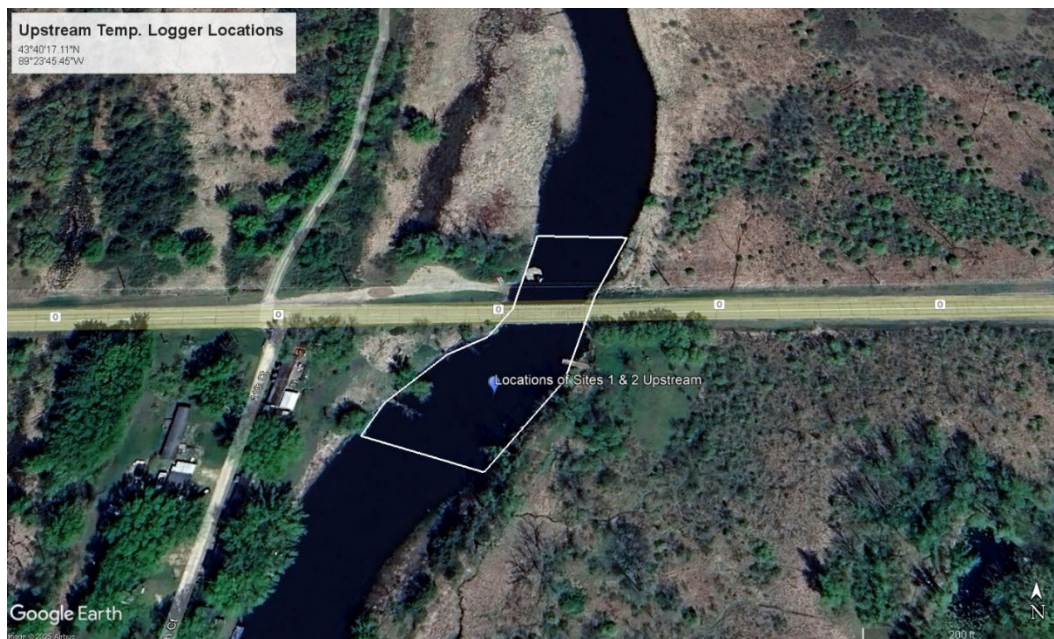
**Figure 17. Temperature monitoring location upstream of Buffalo Lake in 2024.**
